BUREAU OF SHIPS GROUP
TECHNICAL INSPECTION REPORT

⑥ OPERATION CROSSROADS.
U.S.S HUGHES (DD410).
TEST BAKER.

VOLUME II [u] ⑧

USS HUGHES (DD410)

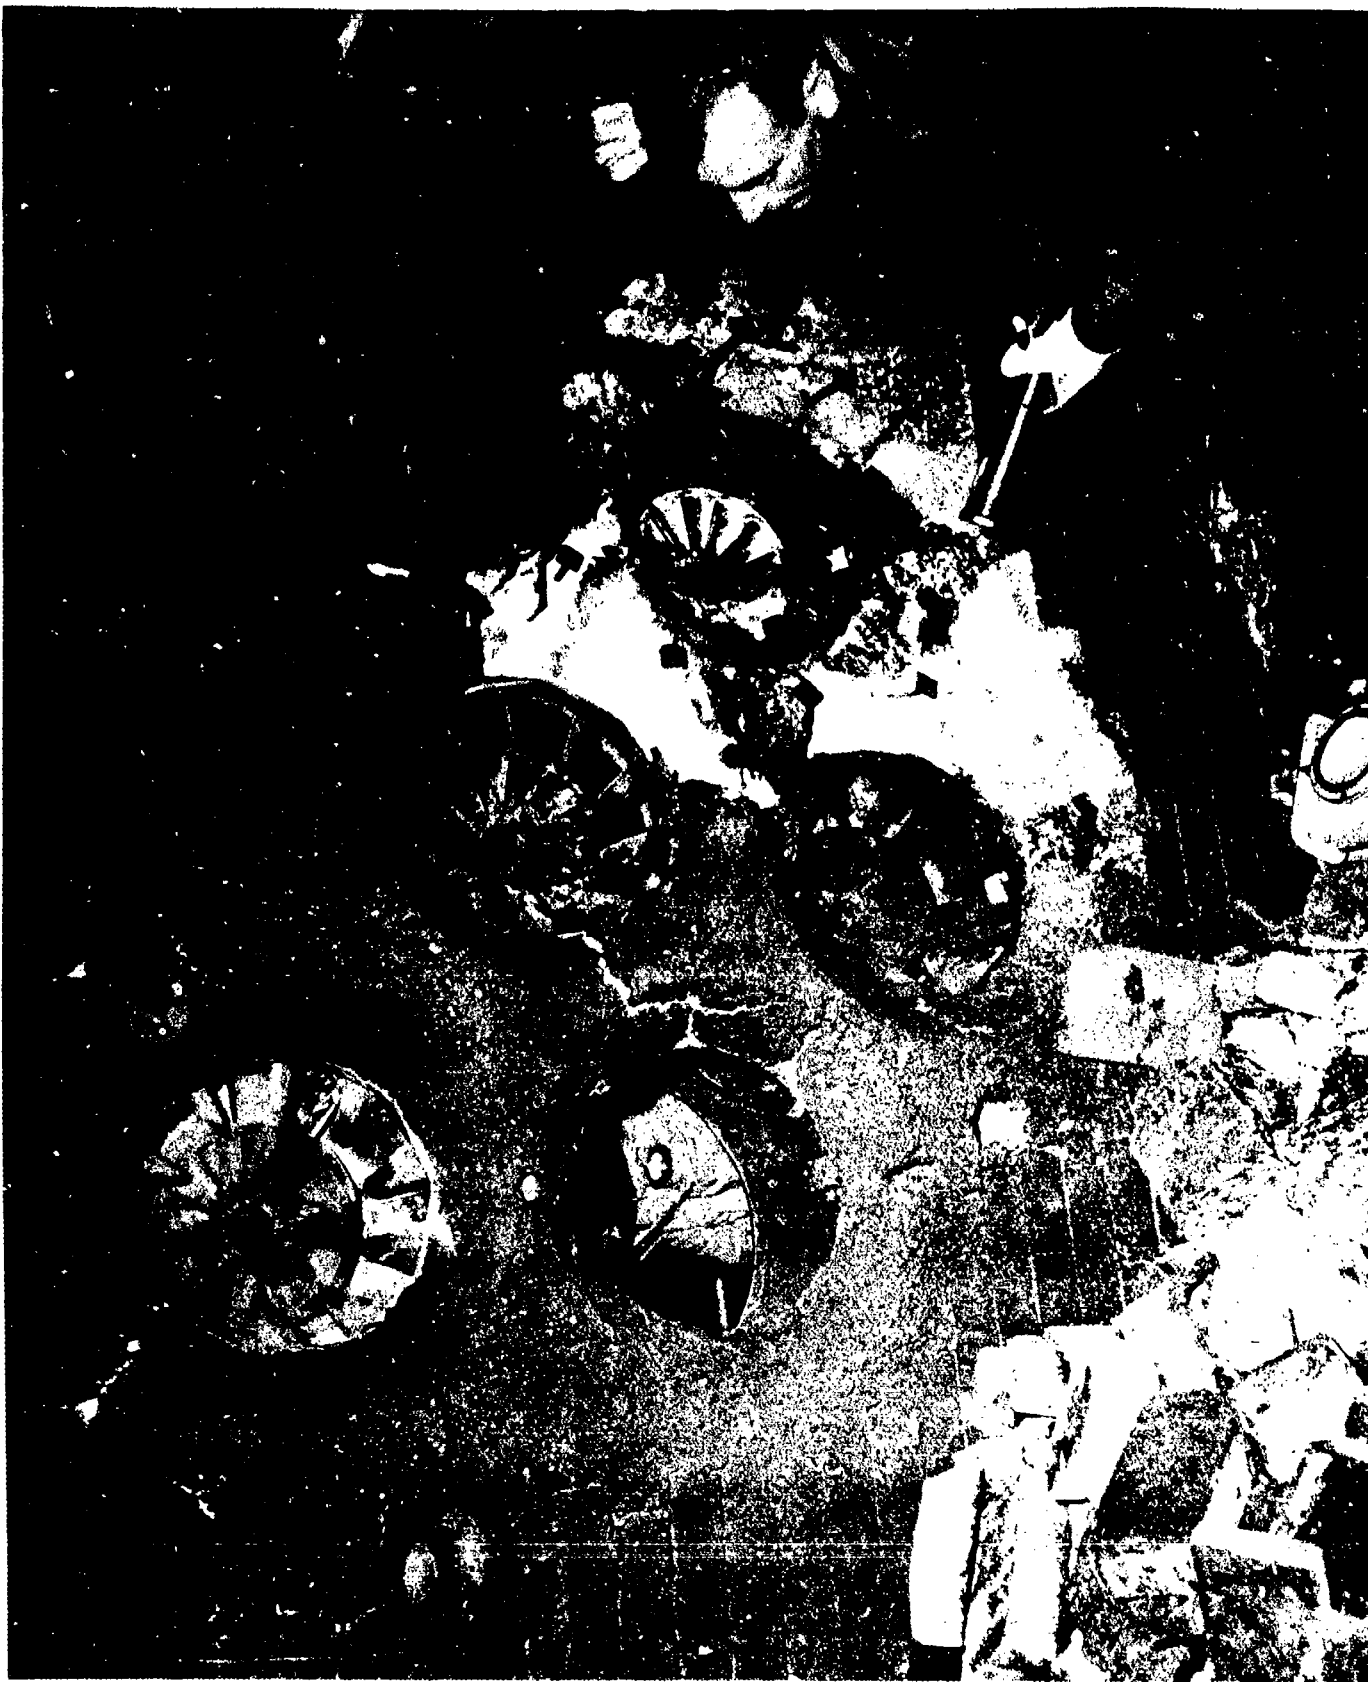
AB-CR-76-2075-10. No. 2 boiler superheater side furnace, front wall.

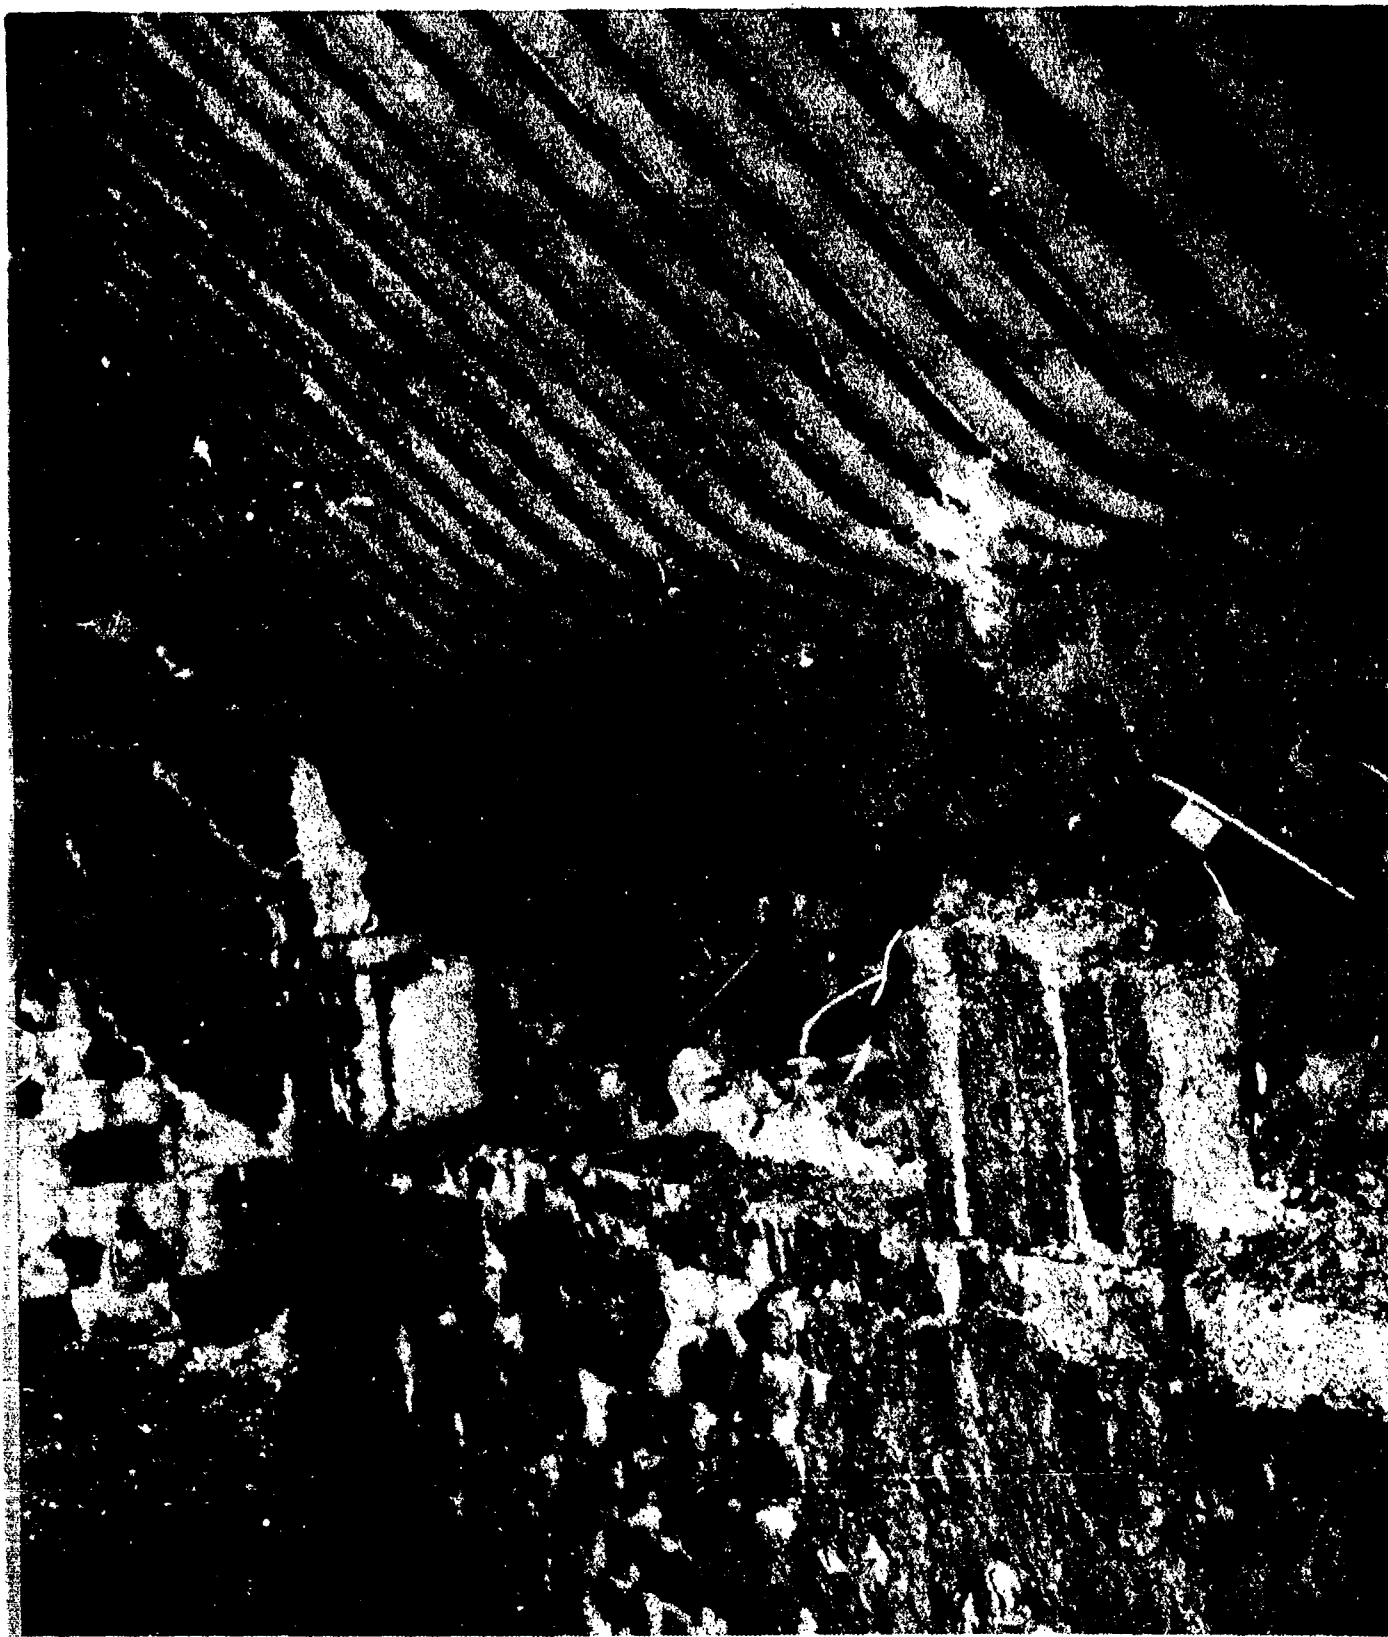
AB-CR-68-2951-11. Interior, saturated side No. 1 boiler, showing displaced brickwork.

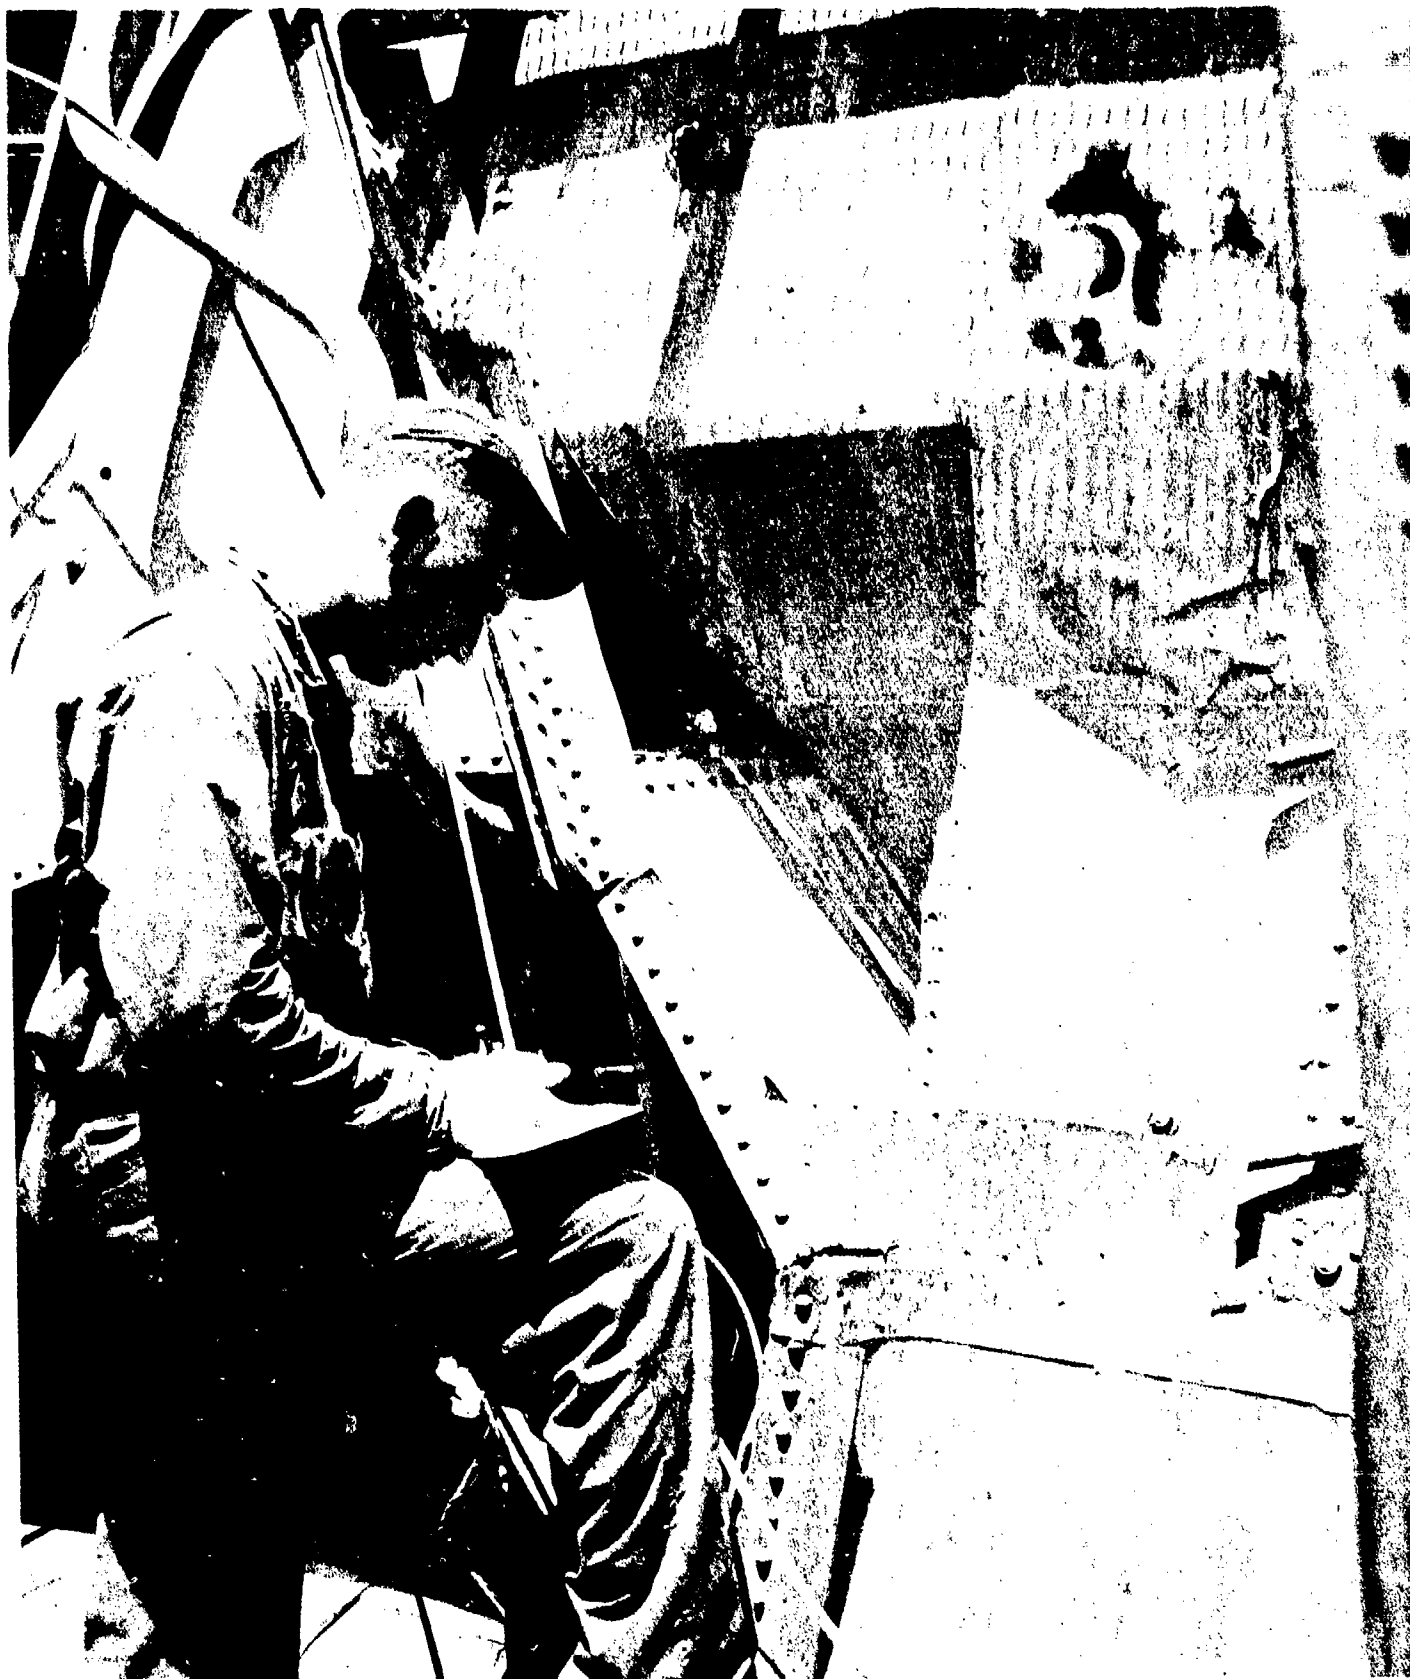
AB-CR-76-2078-1. No. 2 boiler uptake, port side.

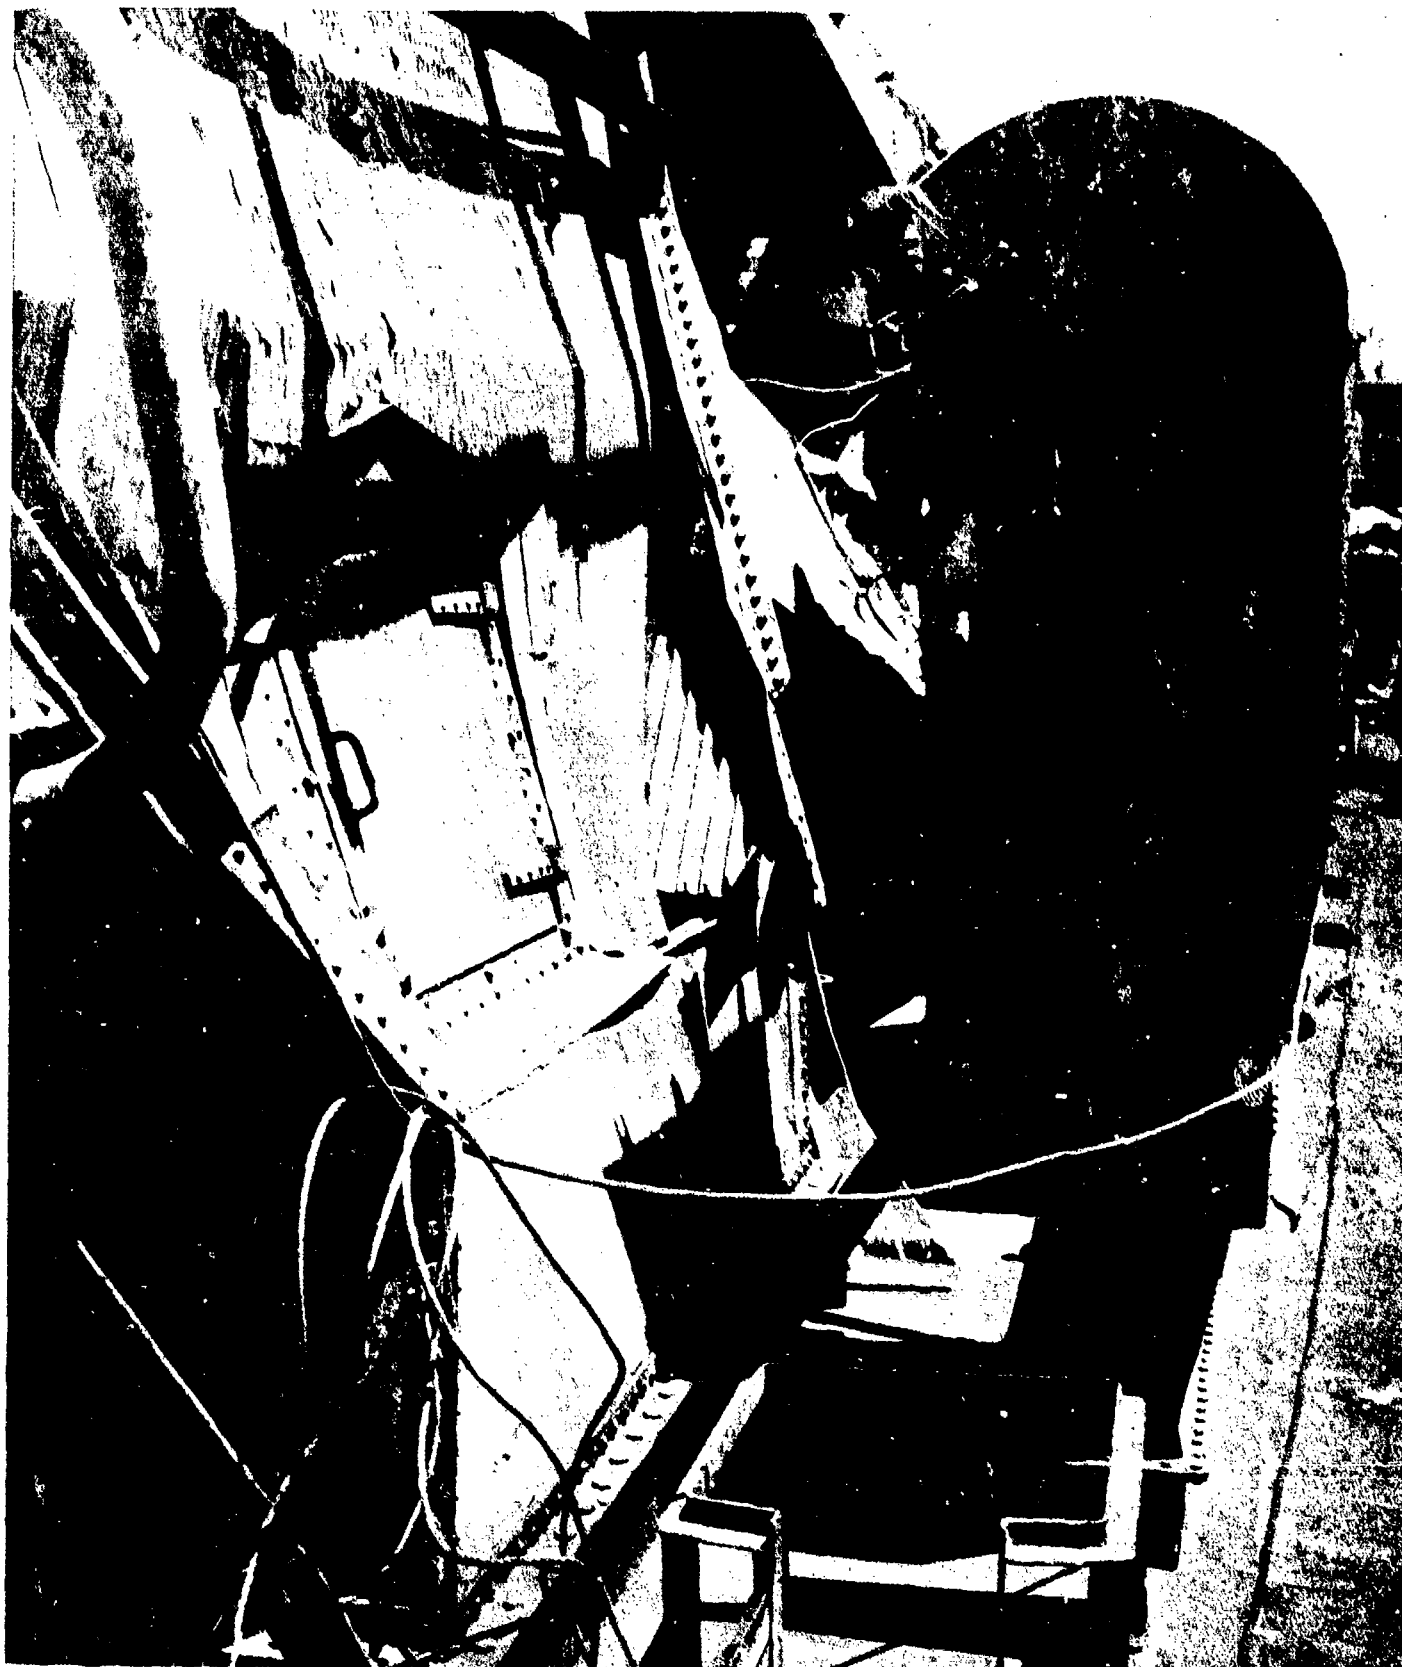
AB-CR-76-2078-2. No. 2 and 3 boiler uptake.

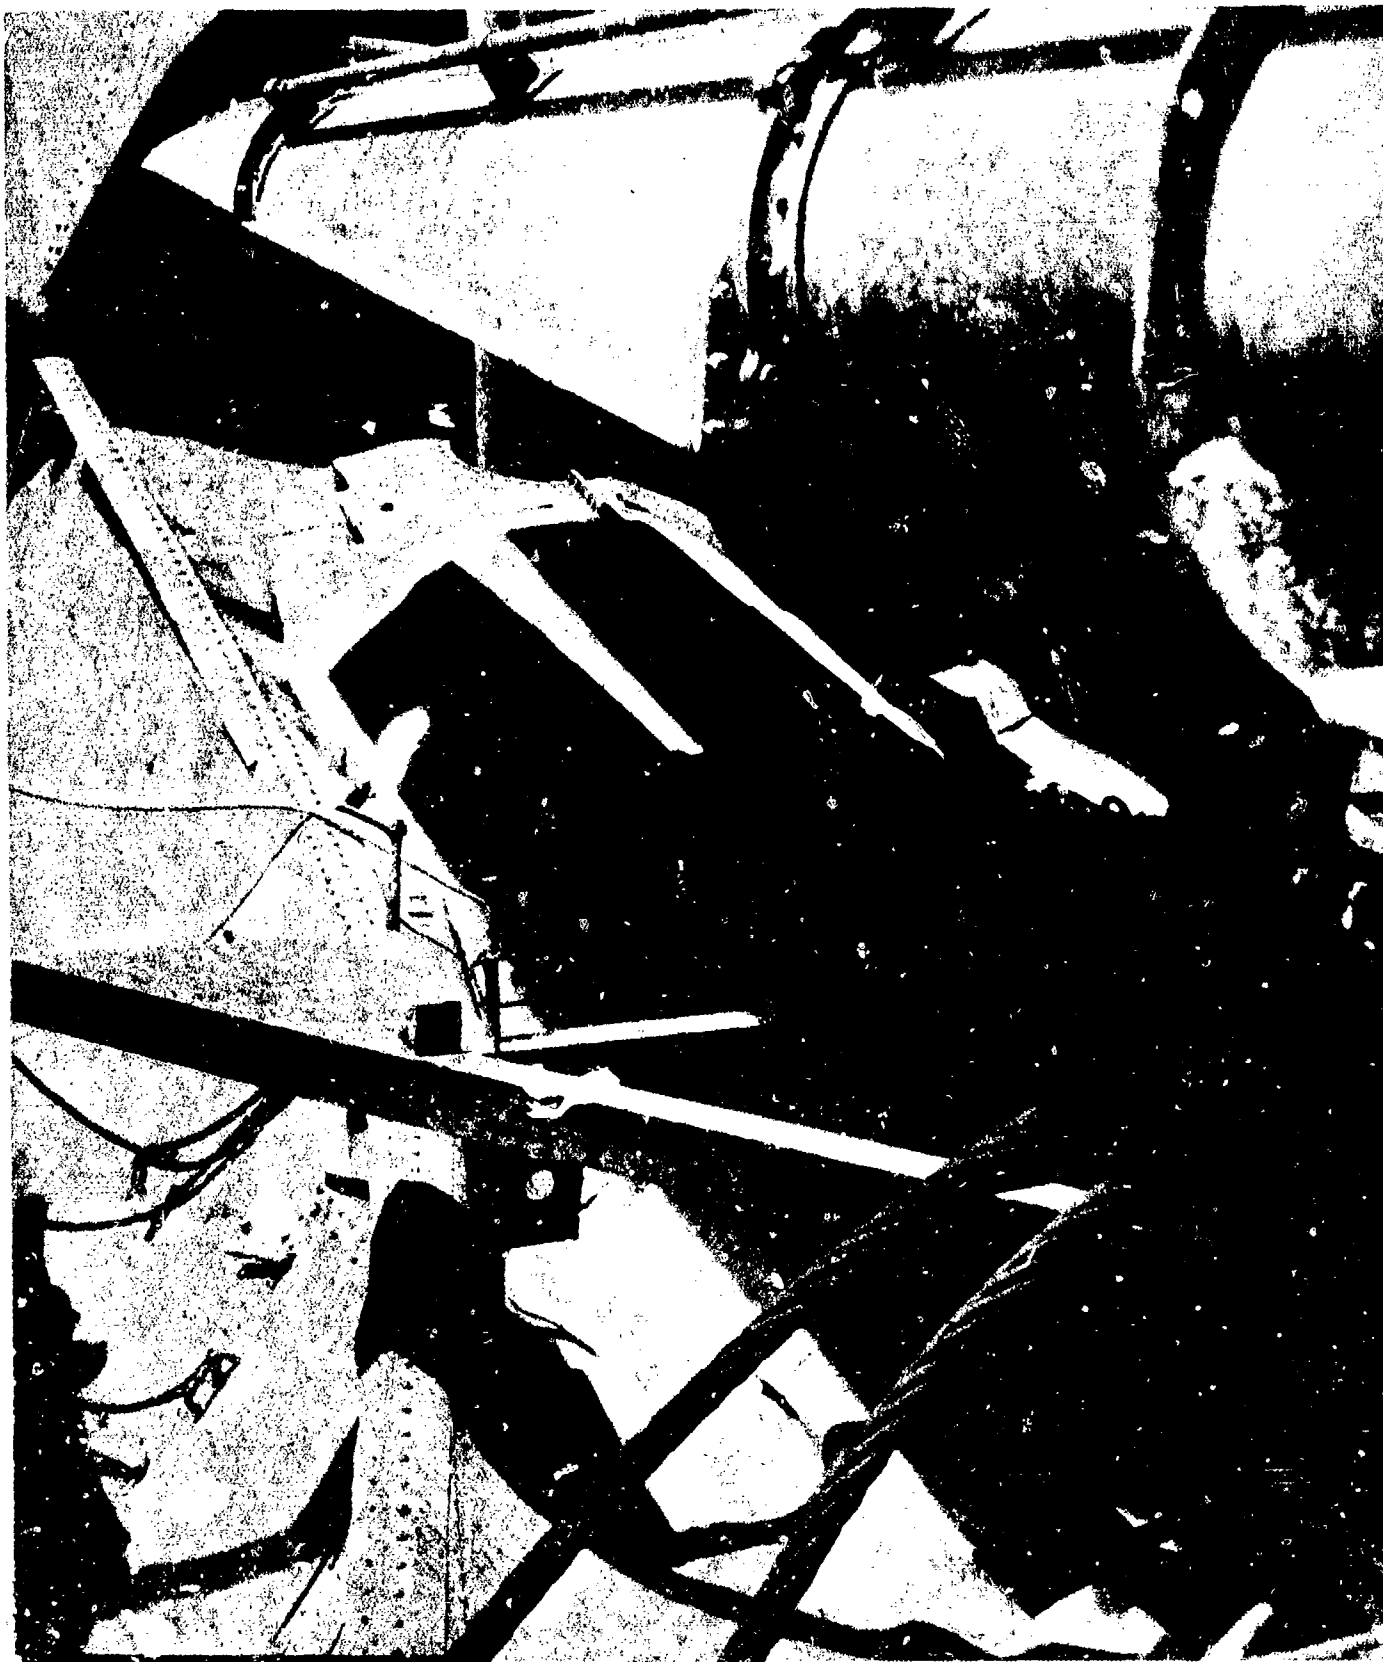
AB-CR-76-2077-8. No. 3 uptake, top of port leg.

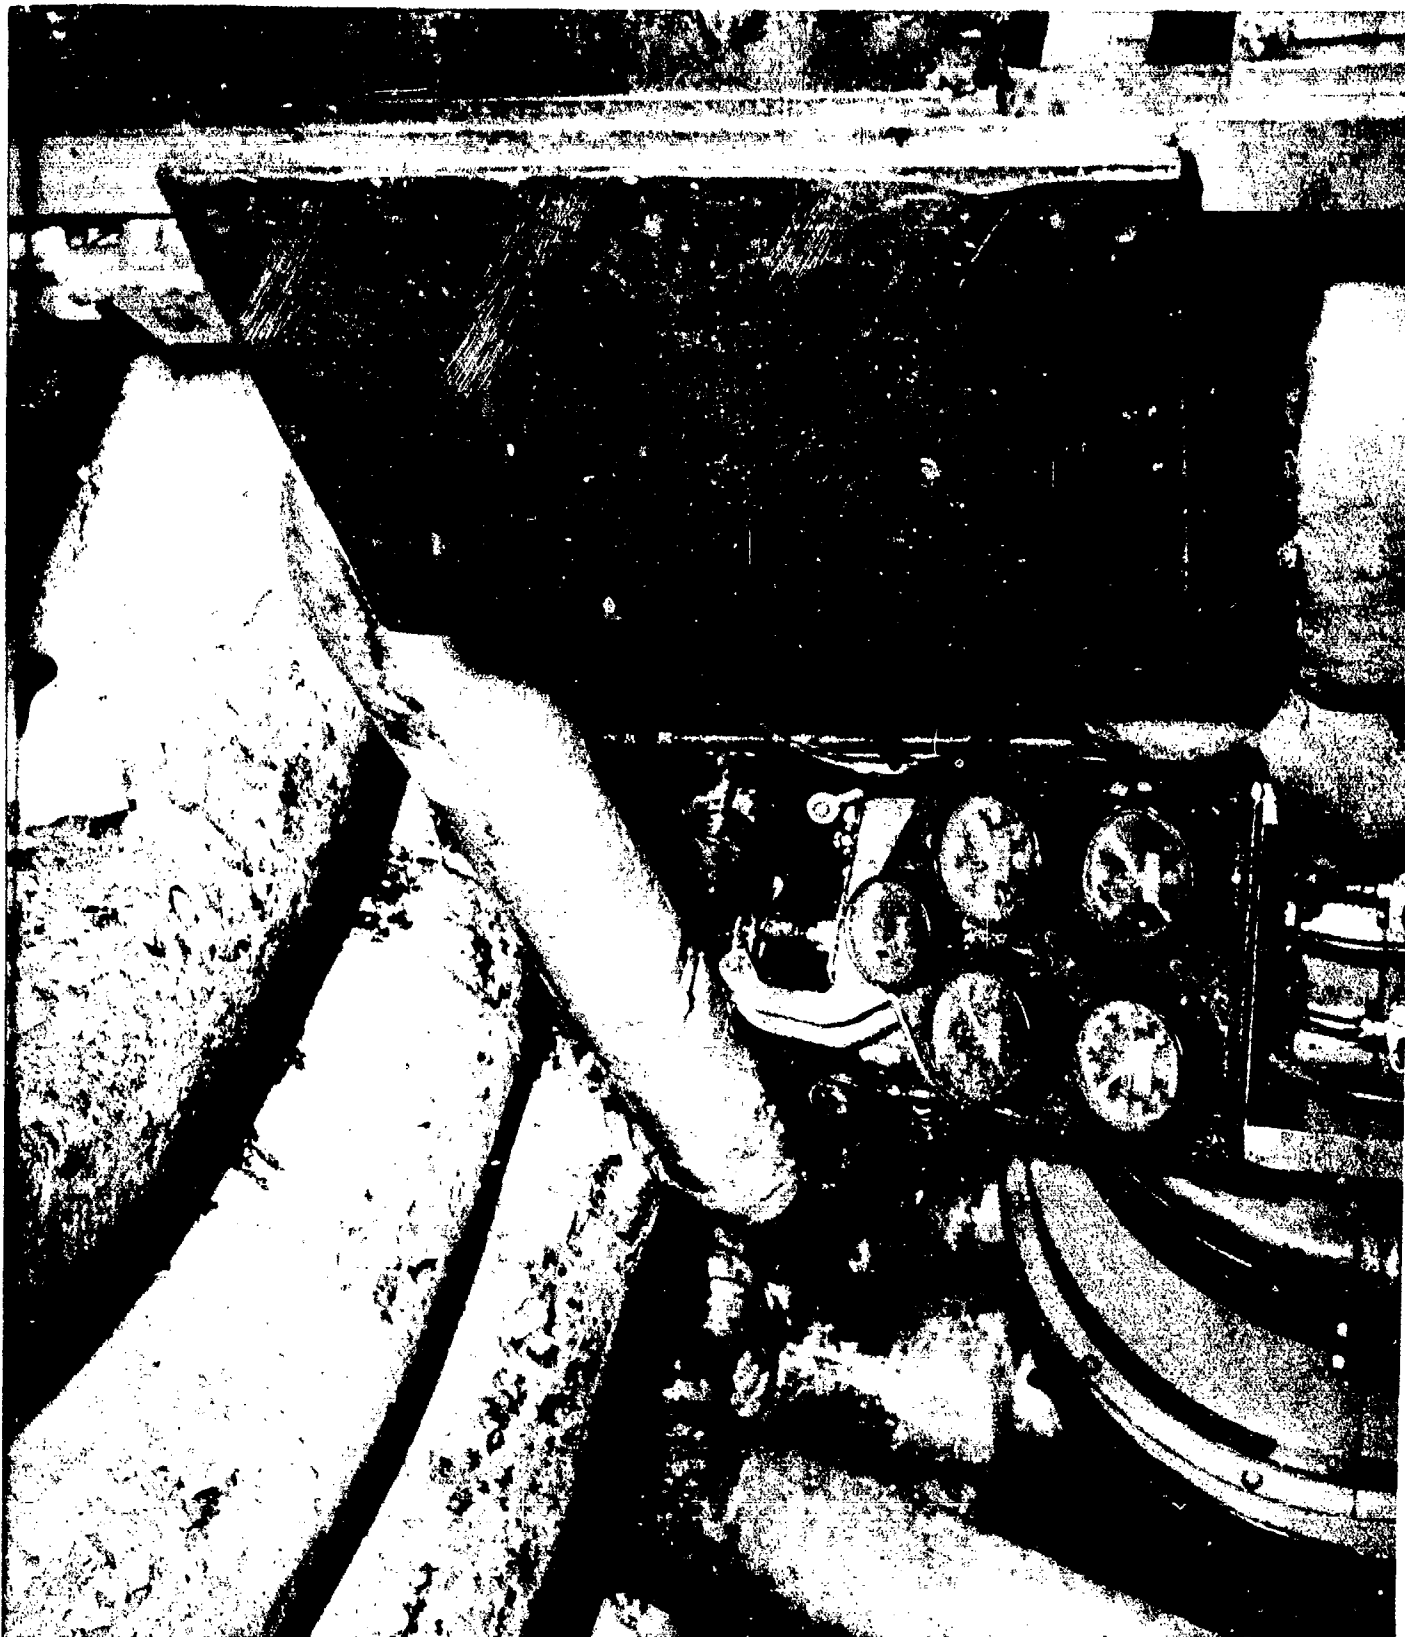
AB-CR-68-2950-11. Showing sagged main steam piping over No. 2 turbo generator No. 1 engine room.

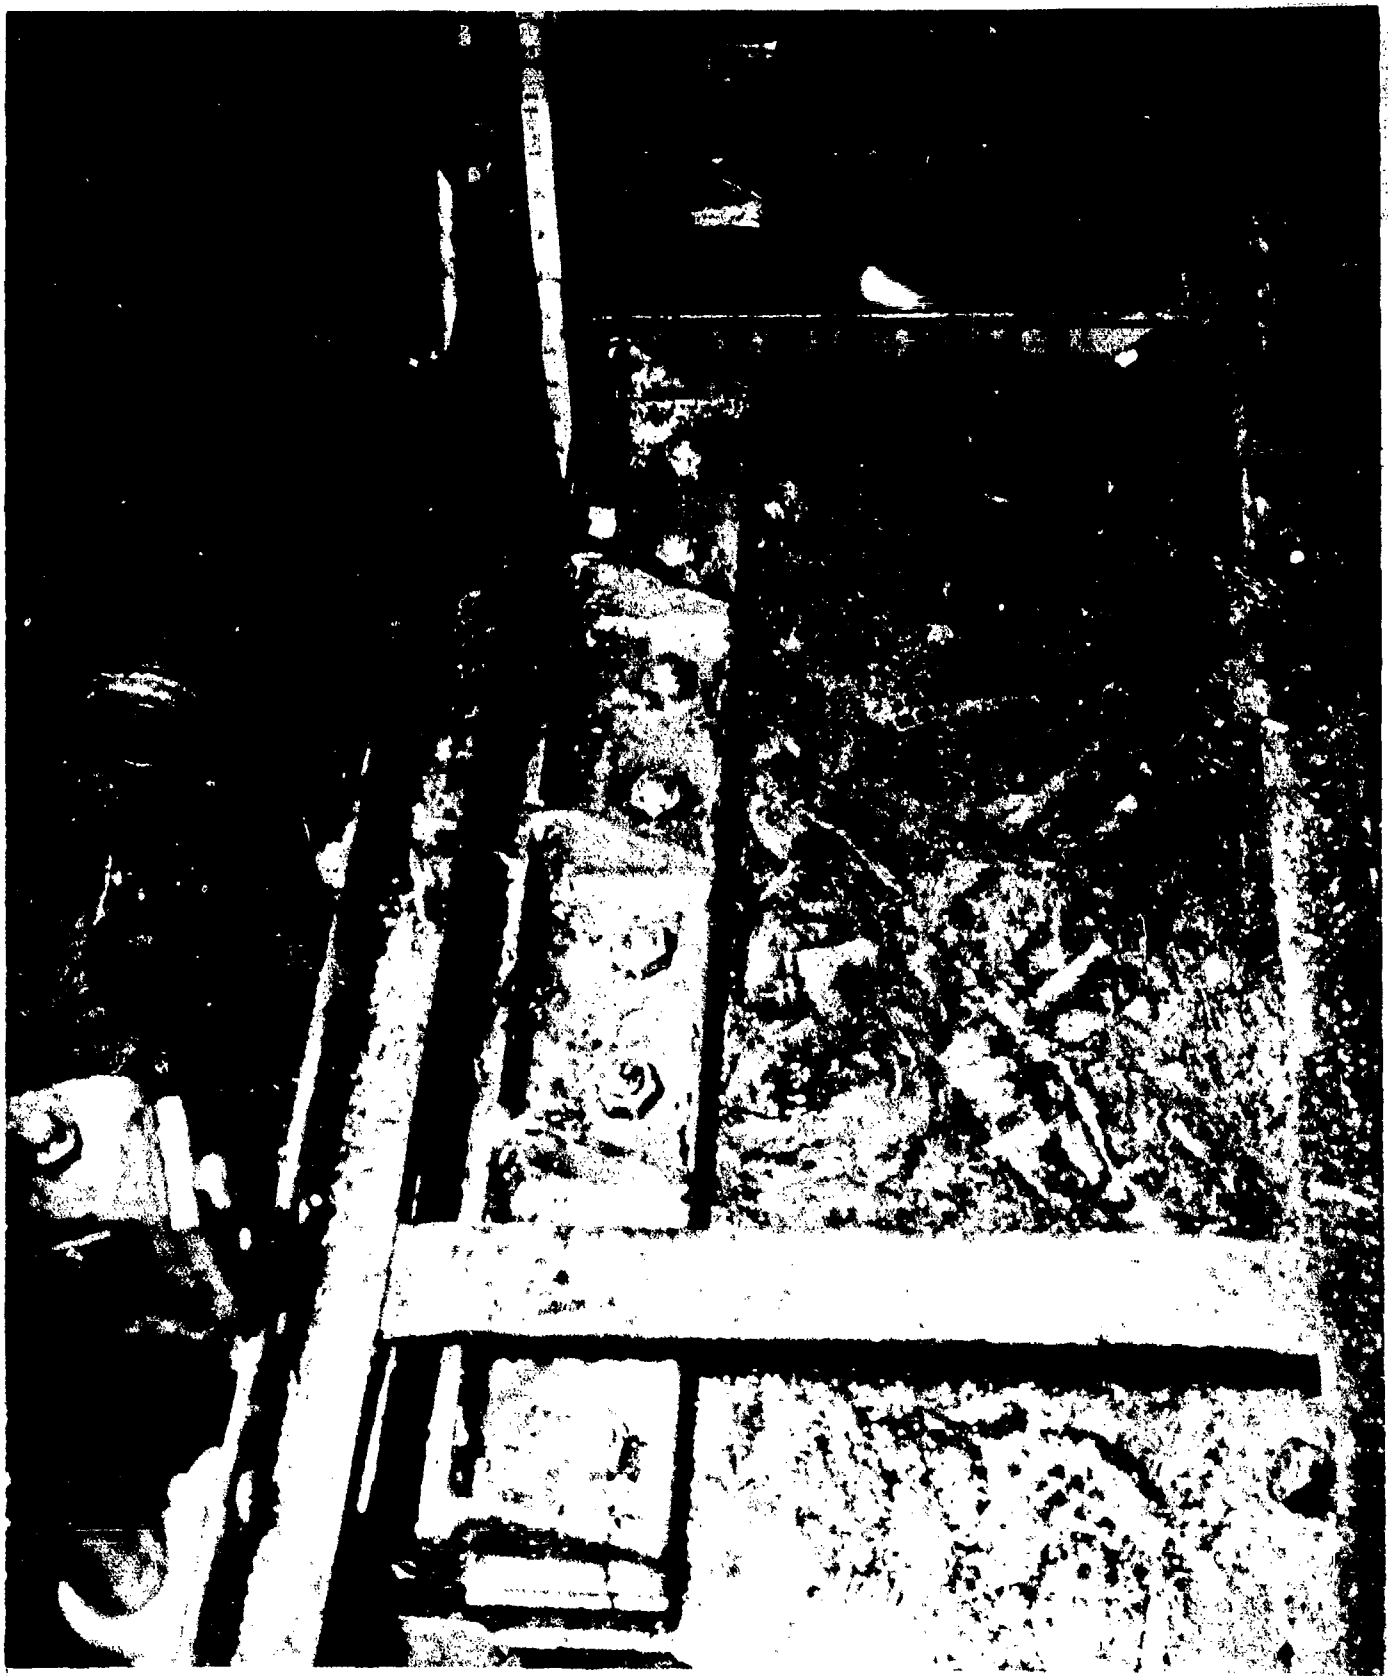
AB-CR-66-151-12. L.P. turbine, flexing plate No. 2 engine room.

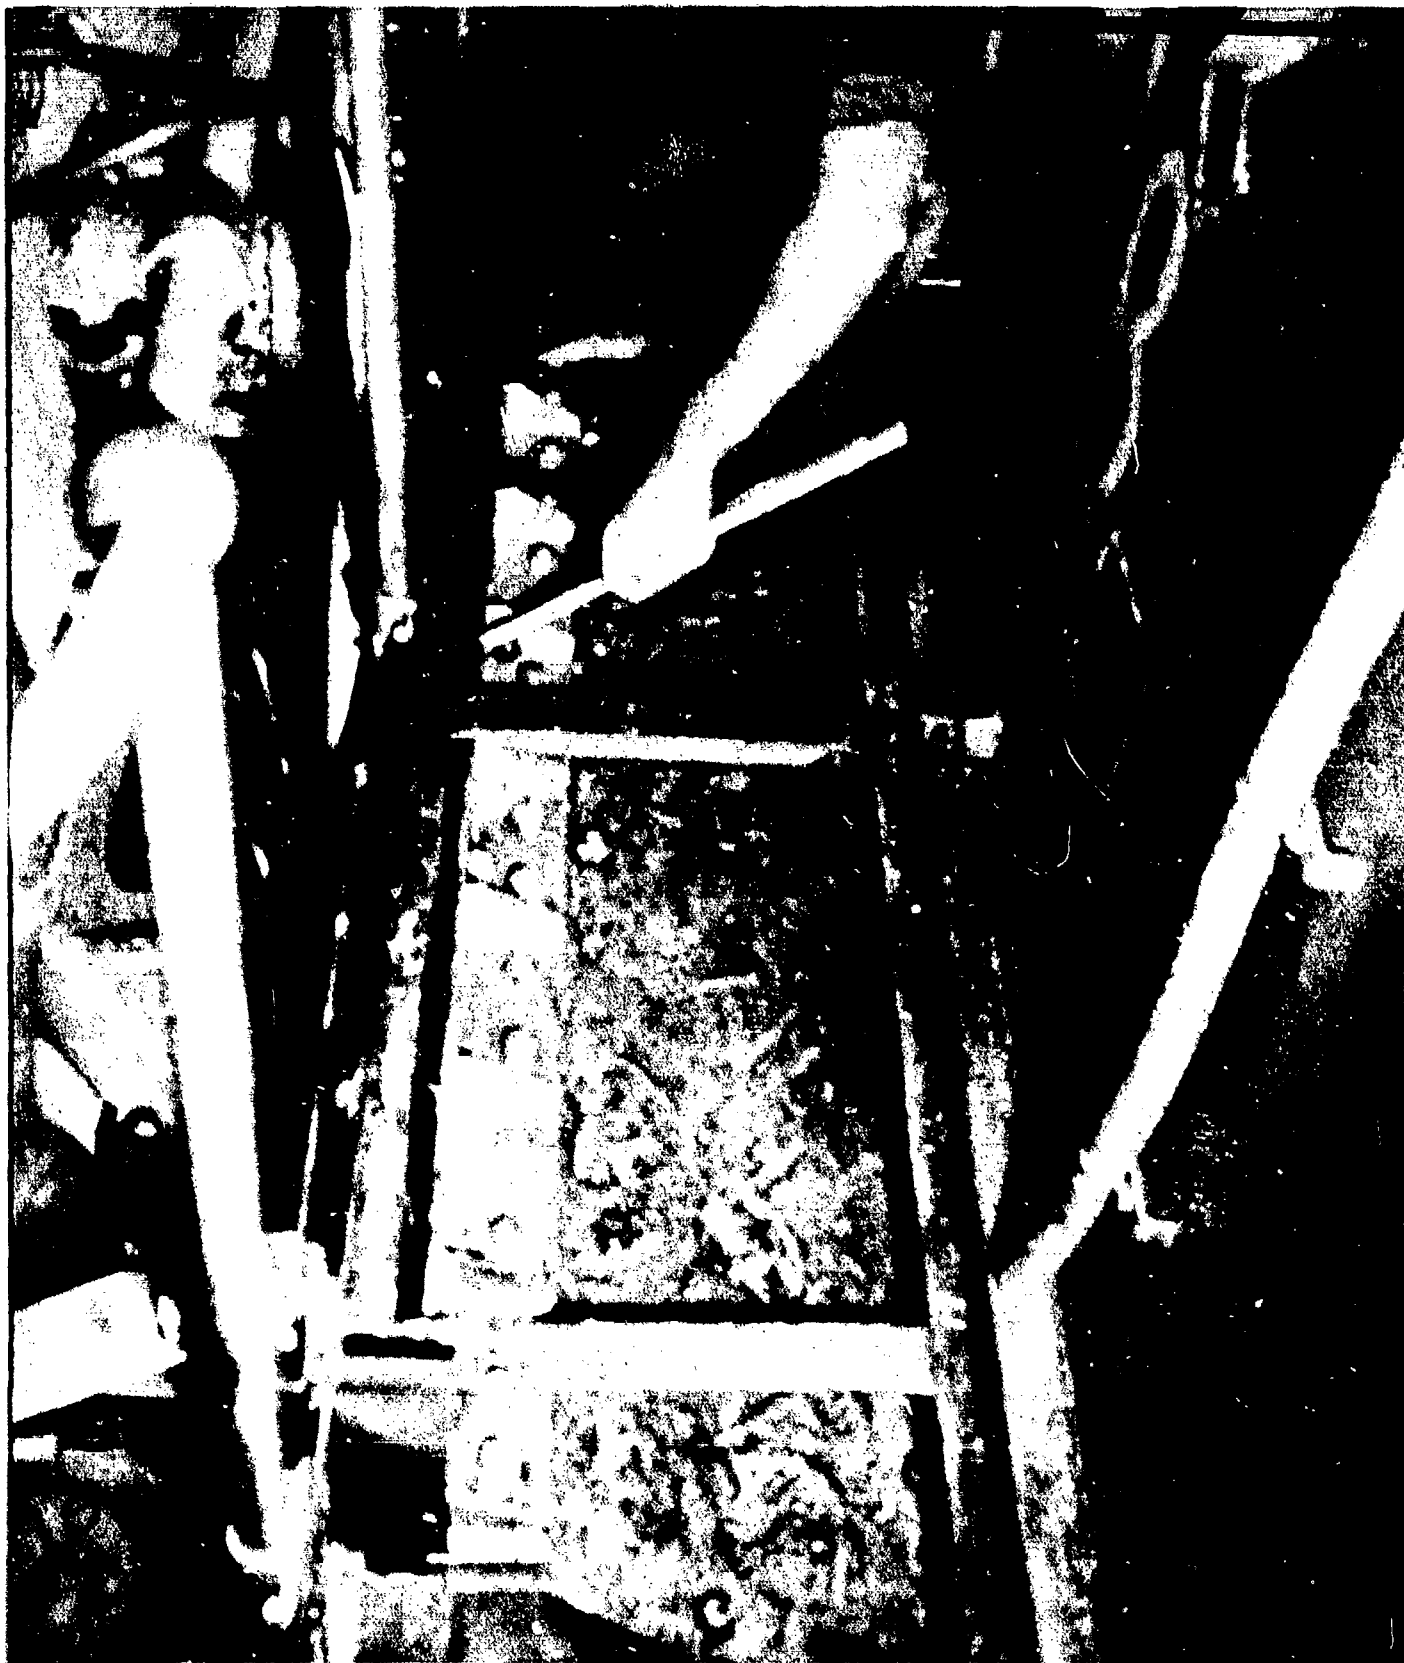
AB-CR-66-153-1. L.P. turbine flexing plate No. 2 engine room.

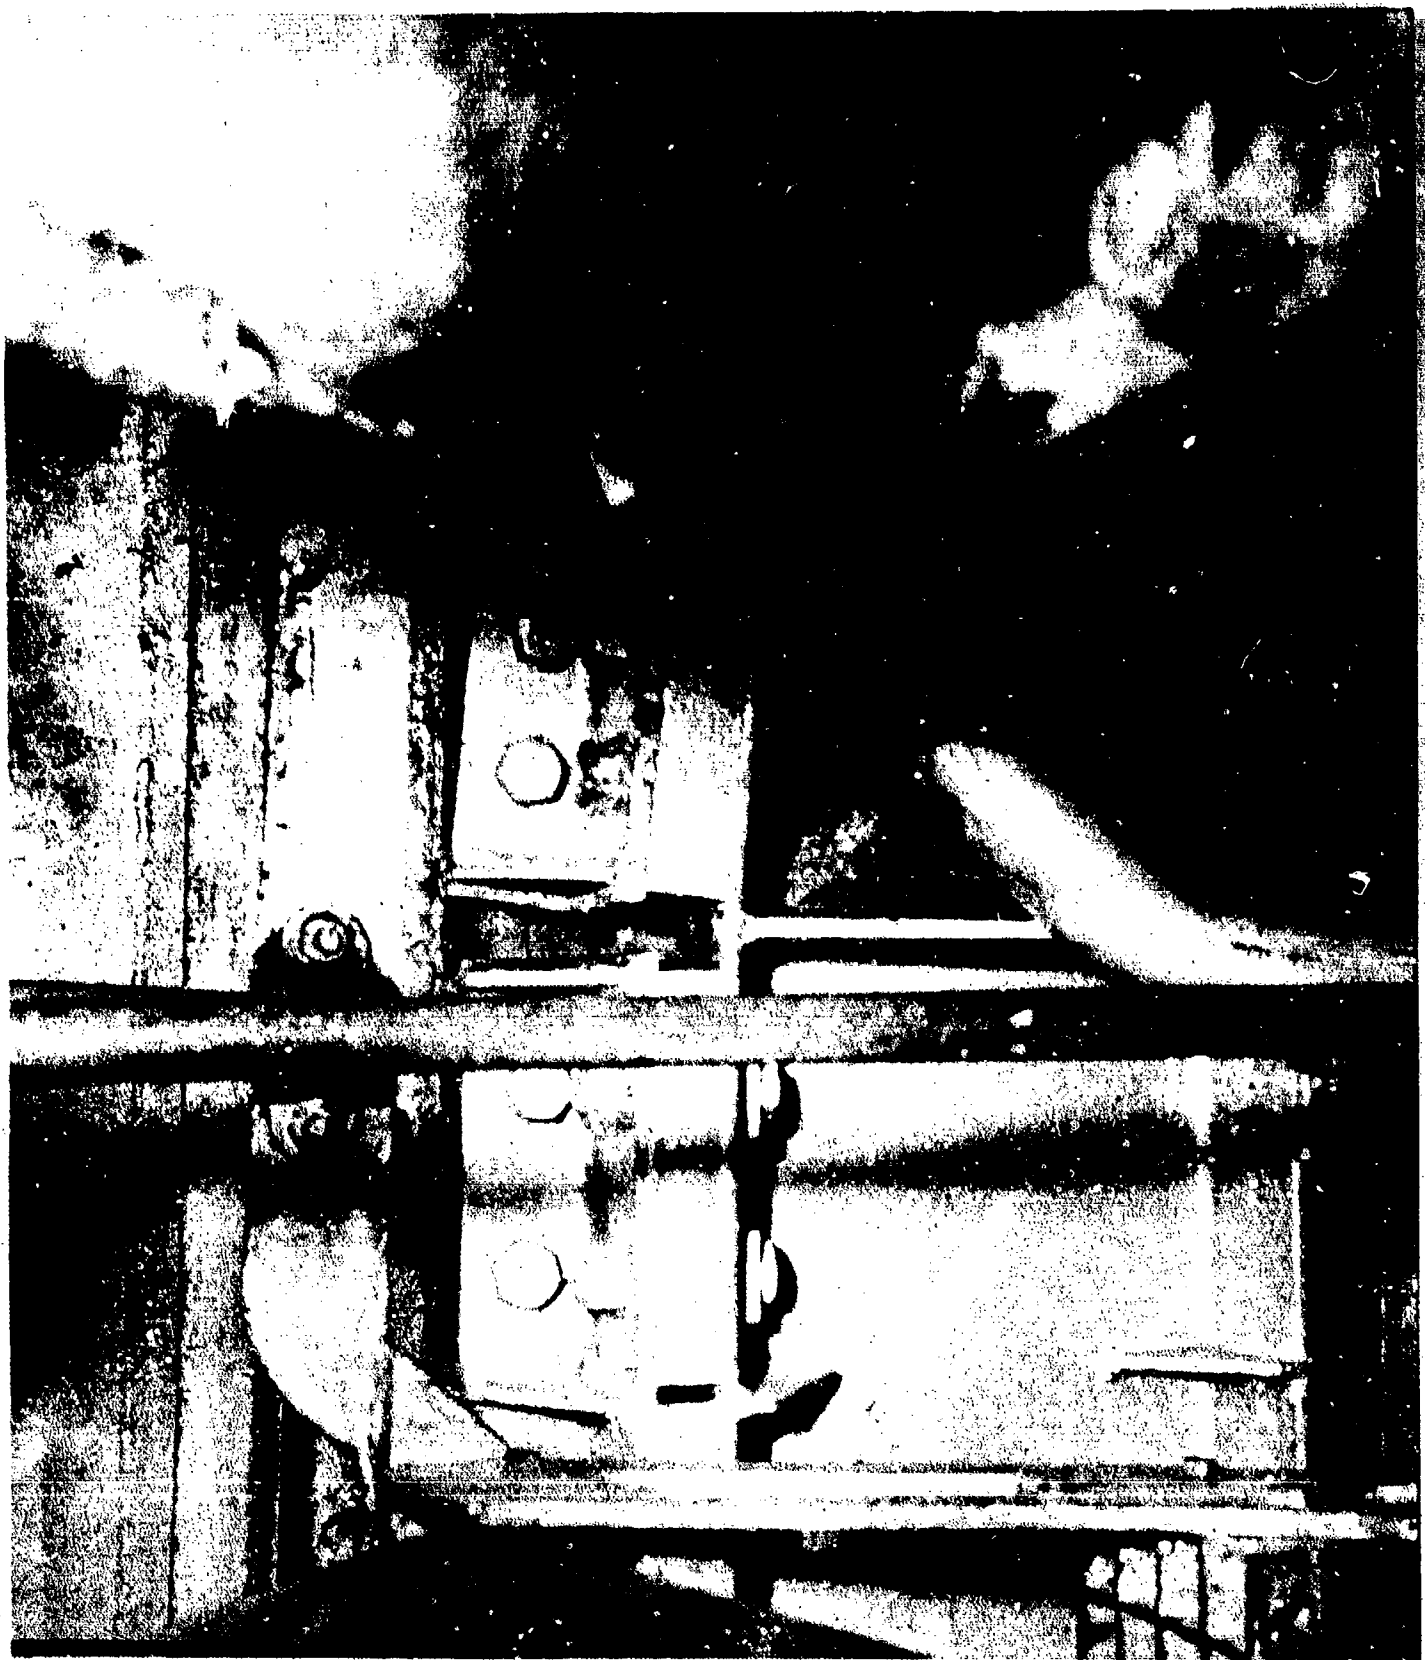
AB-CR-66-153-10. No. 2 engine room, showing space between L.P. turbine flexing plate and I.P. girder flexing plate.

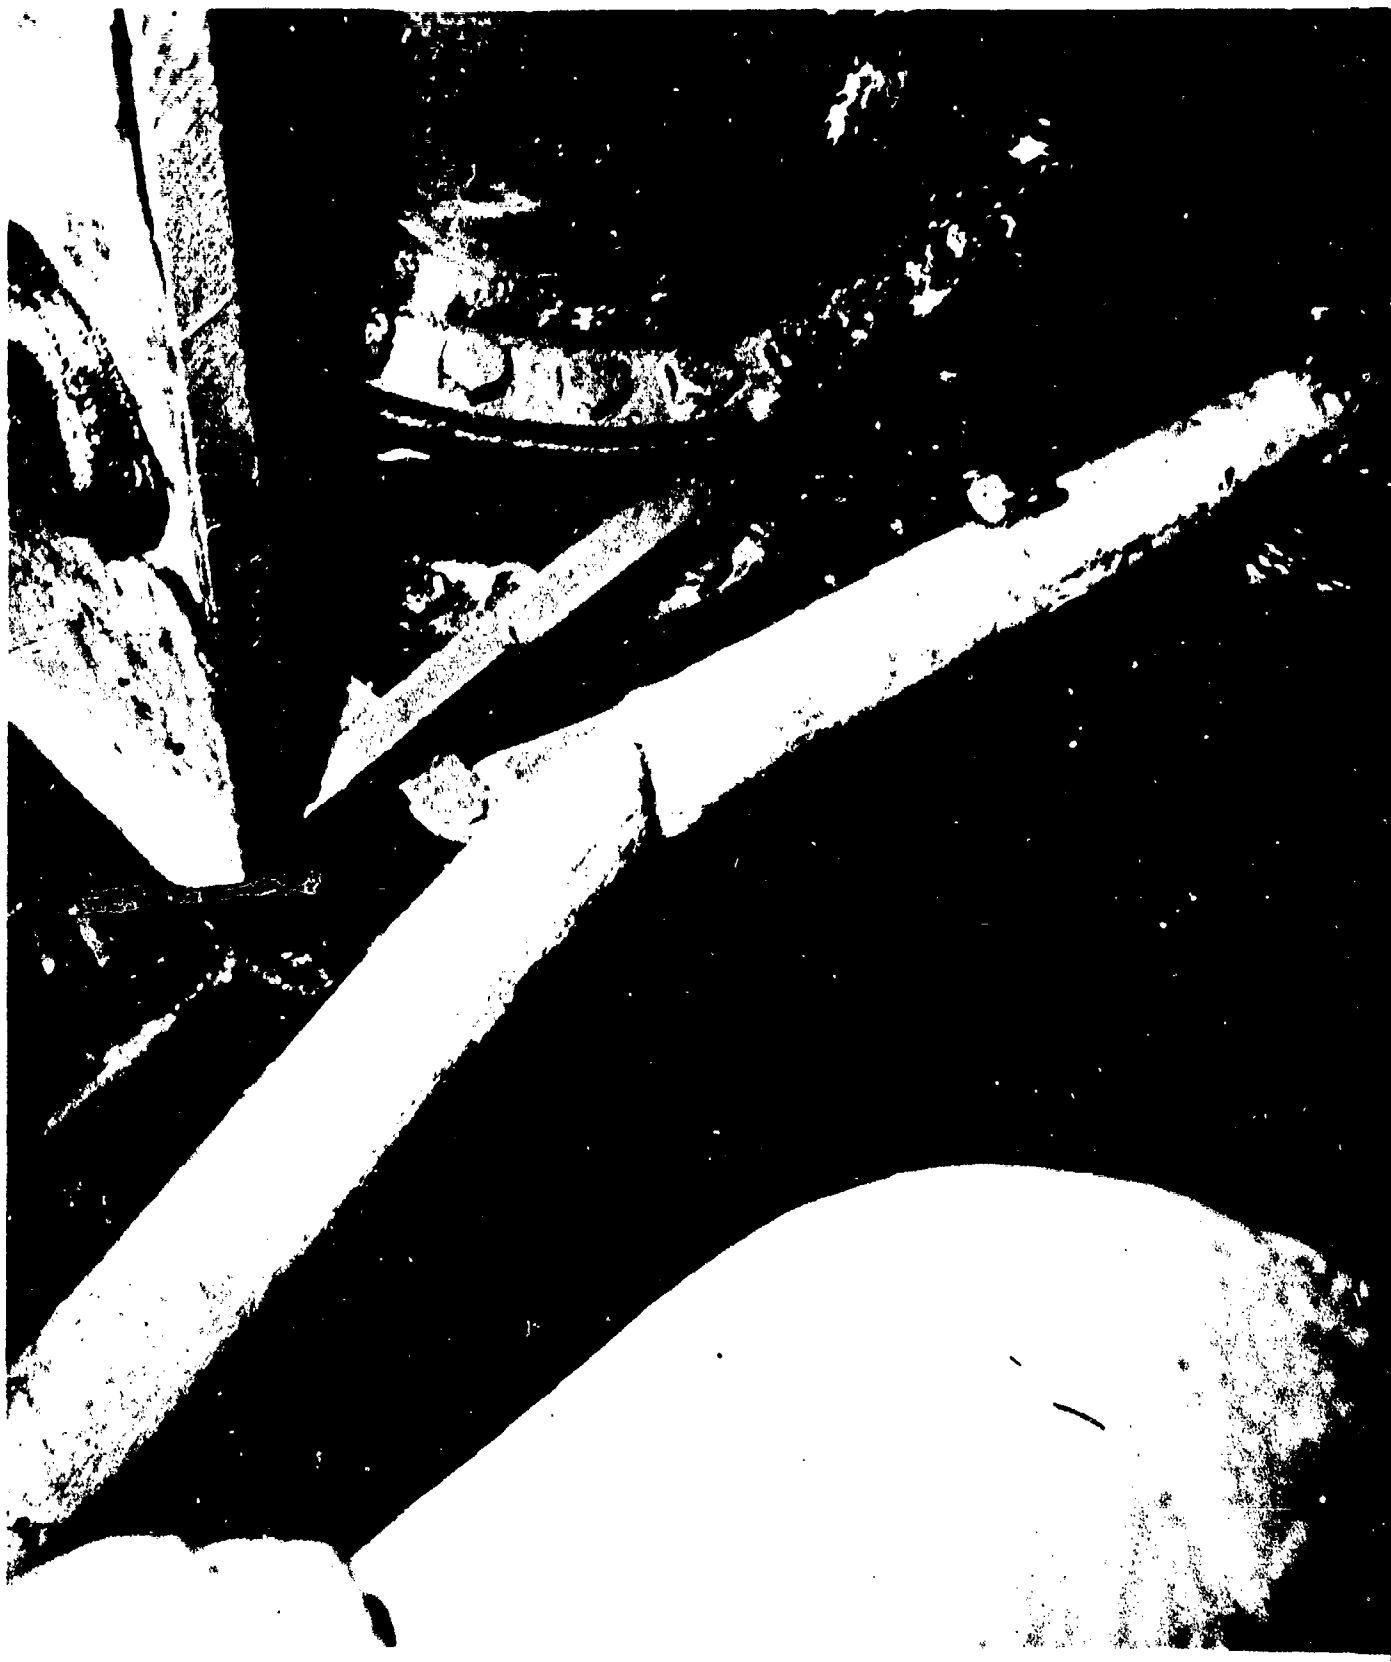
AB-CR-97-4059-1. No. 1 L.P. turbine flexing plate looking to starboard and down.
